**Flood Control Project Maintenance
Levee Inspections**
LMA District Cover Sheet
Spring 2019 Levee Inspection Results

Marysville Levee Commission

Spring 2019 Levee Inspection Results

Waterway			Bank	Unit Miles
Unit No. 01 Simmerly Slough			Left	3.23
	Spring (March - May)	Summer (June - August)	(September - November) Fall	Winter (December - February)
Unit Maintenance Rating (Fall Only)				
Date of Inspection	4/17/2019 - 4/17/2019			
DWR Inspector	Sterling York			
Accompanied By	Frank Miller Marysville Levee District

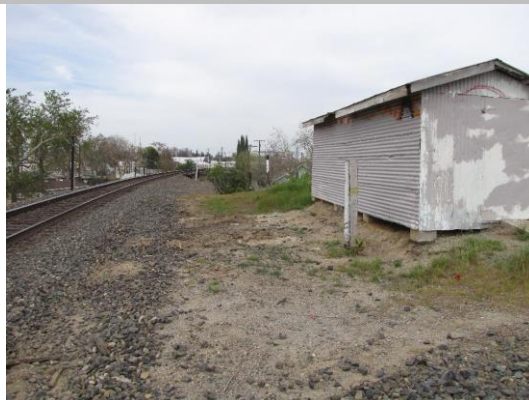
Photo 1 of 3 : UCIP_SP_2019_52819_72696.jpg

LM Start	0.58	Rating **	M	Issue No.	46
LM End	0.58	Issue Type +	En	Location *	
Category	Supplemental			GPS Latitude/Longitude	
				Start	End
Item	DWR UCIP Field Study			39.136556 °	39.136556 °
				-121.583626 °	-121.583626 °
DWR ID	25059				
Comment Code					
Inspector Comment					
FS_ID:52819 DS_ID:25059 EP_NO: N/A Repair Type: Non-Urgent Crossing Status: Indicator Found UCIP Comments: 03/14/2013 Need to coordinate with owner to determine status of crossing, details of crossing (install date and pipe size) and CVFPB permit number issued. (DWR UCIP - O. Magana) FIELD_STRUCT_DESC: Communication line marker found near levee crown. FS Date: 3/14/2013

View of landward side.

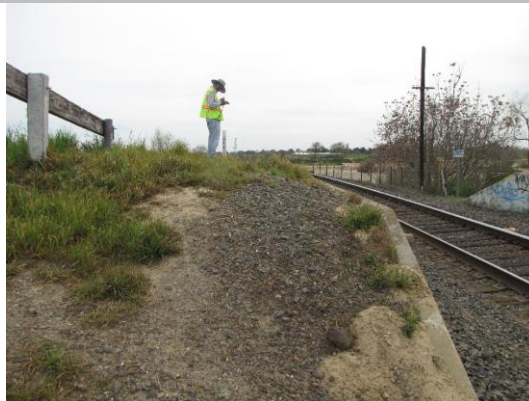
Photo 2 of 3 : UCIP_SP_2019_52819_72695.jpg

LM Start	0.58	Rating **	M	Issue No.	46 (cont)	
LM End	0.58	Issue Type +	En	Location *		
Category	Supplemental			GPS Latitude/Longitude		
				Start	End	
Item	DWR UCIP Field Study			39.136556 °	39.136556 °	
				-121.583626 °	-121.583626 °	
DWR ID	25059					
Comment Code						
Inspector Comment						
FS_ID:52819 DS_ID:25059 EP_NO: N/A Repair Type: Non-Urgent Crossing Status: Indicator Found UCIP Comments: 03/14/2013 Need to coordinate with owner to determine status of crossing, details of crossing (install date and pipe size) and CVFPB permit number issued. (DWR UCIP - O. Magana) FIELD_STRUCT_DESC: Communication line marker found near levee crown. FS Date: 3/14/2013

View of landward side.

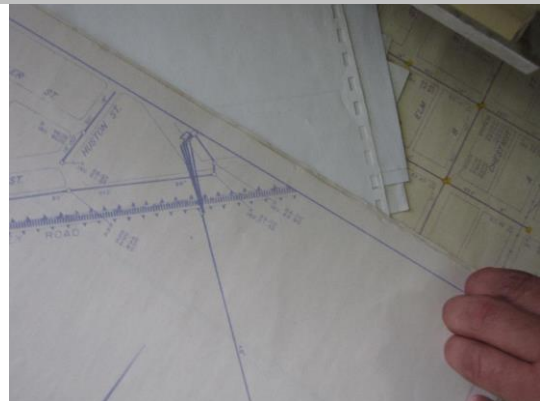
Photo 1 of 3 : UCIP_SP_2019_52824_69830.jpg

Comment Code					
Inspector Comment					
FS_ID:52824 DS_ID:19145 EP_NO: 2149 Repair Type: Non-Urgent Crossing Status: Indicator Found UCIP Comments: 03/14/2013 Depression observed on waterward toe filled with concrete rubble and riprap. Need to coordinate with City to determine records and extent of modifications if any. (DWR UCIP - O. Magana) FIELD_STRUCT_DESC: [17th & Howell Pump Station] 1 of 4: 24-inch steel drainage pipe (instead of 30 inch as specified in permit), buried 15-feet below the crown. Runs parallel to other drainpipes, encased in concrete approximately 1-foot spacing. Pipe extends from storm water pump house to manhole (259 feet) north of landside (LS) toe. Flap gates and vent pipes at waterside (WS) toe. Discharges into concrete distribution box (3-foot by 4 foot). (three 30-inch and one 10-inch pipes and a 48-inch outfall pipe across the berm along the right bank of the Yuba River authorized under Permit No. 2149, 1956-City of Marysville). [Additional Reference(s): DWR Levee Logs, 1993 and 2005] FS Date: 3/14/2013

As-built provided by Marysville Water Treatment Facility.

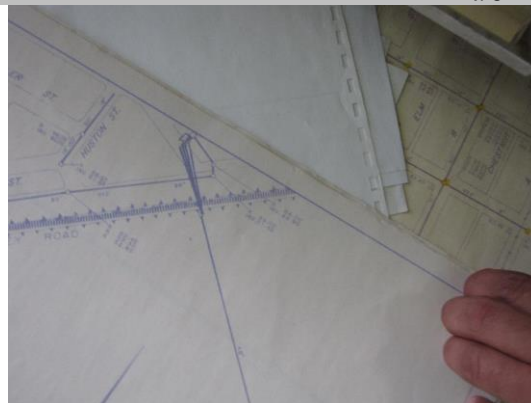
Photo 1 of 3 : UCIP_SP_2019_52825_69835.jpg

Comment Code						
Inspector Comment						
FS_ID:52825 DS_ID:19160 EP_NO: 2149 Repair Type: Non-Urgent Crossing Status: Indicator Found UCIP Comments: 03/14/2013 Depression observed on waterward toe filled with concrete rubble and riprap. Need to coordinate with City to determine records and extent of modifications if any. (DWR UCIP - O. Magana) FIELD_STRUCT_DESC: [17th & Howell Pump Station] 2 of 4: 10-inch steel drainage pipe, buried 15-feet below the crown. Runs parallel to other drainpipes, encased in concrete approximately 1-foot spacing. Pipe extends from storm water pump house to manhole (259 feet) north of landside (LS) toe. Flap gates and vent pipes at waterside (WS) toe. Discharges into concrete distribution box (3-foot by 4-foot). (three 30-inch and one 10-inch pipes and a 48-inch outfall pipe across the berm along the right bank of the Yuba River authorized under Permit No. 2149, 1956-City of Marysville). [Additional Reference(s): DWR Levee Logs, 1993 and 2005] FS Date: 3/14/2013

As-builts provided by Marysville Water Treatment.

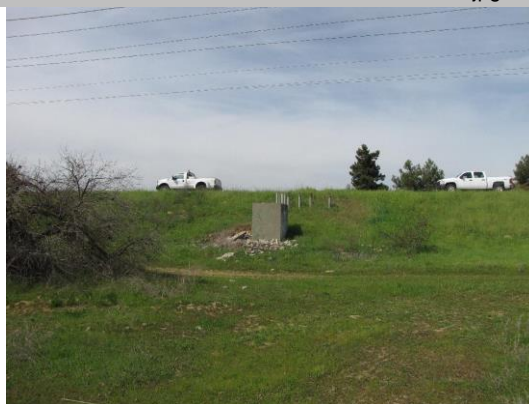
Photo 2 of 3 : UCIP_SP_2019_52826_69839.jpg

View of waterward side.

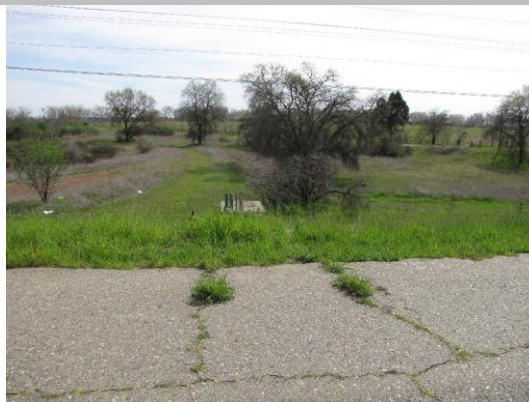
Photo 2 of 3 : UCIP_SP_2019_52827_69826.jpg

City of Marysville Wastewater Treatment Facility records indicating multiple crossings through levee.

View of waterward side.
